ACOUSTIC METHOD OF VALUATION OF SHIPS' DRIVE MECHANISM OPERATION

JACEK DOMAGALSKI, JERZY DOBRZENIECKI

Polish Naval University in Gdynia
Śmidowicza 69, 81-103 Gdynia
j_dobrzniecki@wp.pl

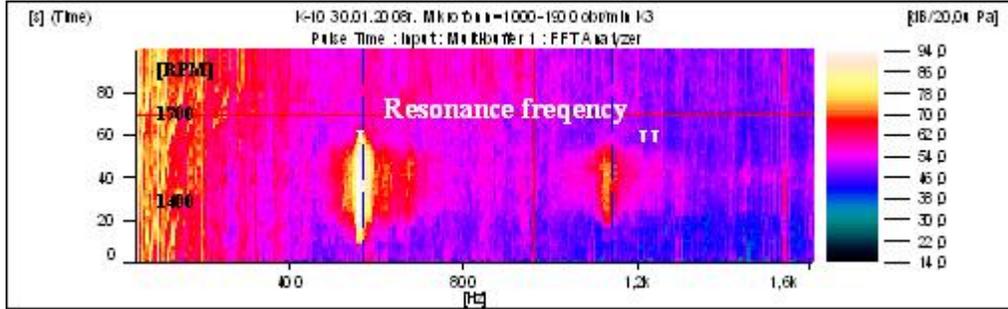
Fig.1 Spectrogram of recorded noise of a ship at rotational speed $n = 1000 - 1900$ rpm

The presented spectrogram one may see two distinct zones of increased acoustic pressure in two frequency bands; first from approx. of 530 to approx. of 570 [Hz]. The second band occurs in band from approx. 1120 [Hz] to 1140 [Hz]. This second band is the second harmonic of first band. Basing on the presented spectrogram was carried out the graph of relation between acoustic pressure level and main engine rotational speed (Fig. 2).

Additionally were carried out measurements of noise levels during smooth increase of cruising speed from minimum to maximum. Due large number of results from these tests only one spectrogram (Figure 1) is presented. It shows change of sound intensity [dB/A] versus change of rotational speed of the main engine and frequency. This analysis was made using constant bandwidth filters of 4 [Hz] in frequency band from 6 [Hz] to 1600 [Hz].

In this spectrogram are also visible two zones as in the spectrogram presented in figure 1, for the same frequency ranges. In order to determine vibrations level and exact location of the source of vibrations acceleration has been carried out the spectral analysis for individual rotational speeds of main engines. These analyses were carried out for measurements recorded at the foundation frame of the main engine, at the shaft's thrust bearing and at the frame in the stern room. The exemplary spectrum of vibrations recorded in the foundation frame of the main engine did not show zones of increased vibrations in the entire range of main engine rotational speed. Therefore it excludes the main engine as the source of excessive noise.

They are also visible in the spectrogram of noise; figure 1 and 3. Spectra of vibrations recorded in the frame in the stern room are presented in figures 8, 9 and 10.

In spectrograms and spectra obtained from the measurements one may see zones with increased noise levels in frequency bands from 530 to 570 [Hz] and from 1120 to 1140 [Hz]. Processed signals of vibrations recorded for the foundation frame of the main engine did not contain vibrations within above frequency bands. Lack of these bands in spectra suggests that the main engine is not the source of searched noise.

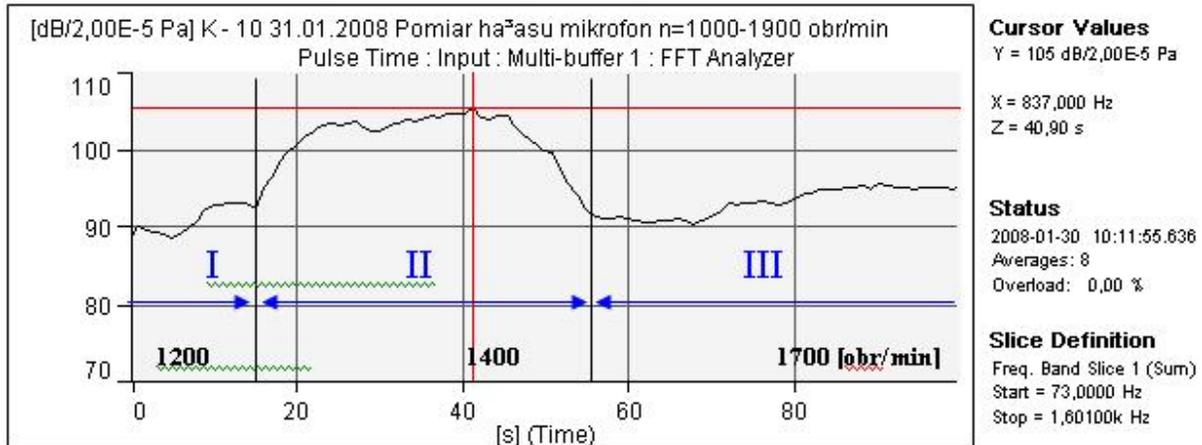
Fig.2 Acoustic pressure level depending of time at change of rotational speed $n = 1000 - 1900$ rpm

In the presented drawing are visible three zones designated as I, II and III. Zone I presents change of noise levels in rotational speed change range from 1000 to 1250 rpm. The second zone was performed for rotational speed from 1250 to 1450 rpm. Third: from 1550 to 1950 rpm. In the second zone one may see distinct increase of noise level.

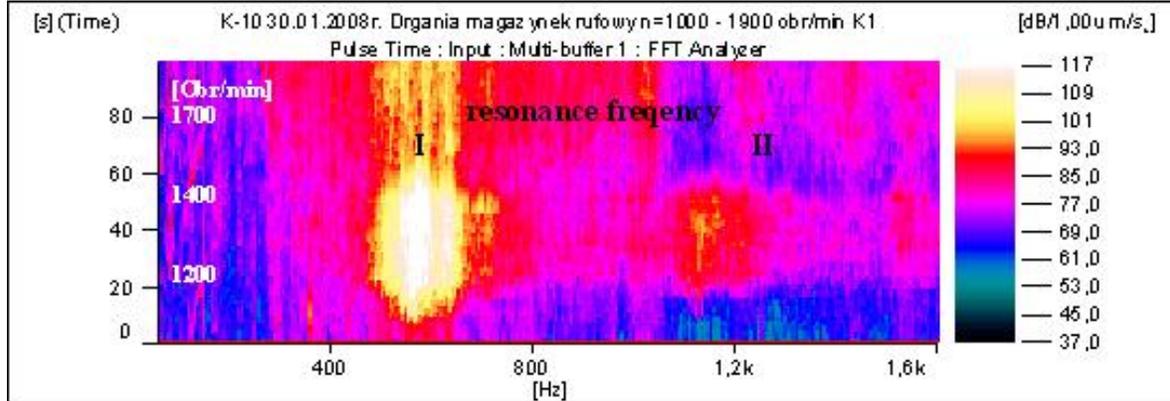
Fig.3 Spectrogram of vibrations recorded in the stern room. $n = 1000 - 1900$ rpm

Additionally were made measurements of vibrations in the stern room for entire range of ship speed. The spectrogram from these tests is presented in the figure No 3.

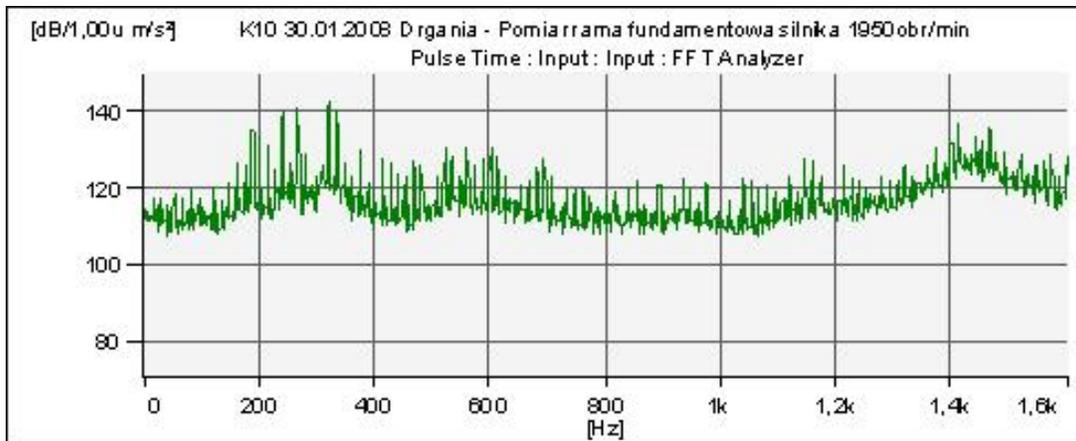
Fig.4 Spectrum of accelerations recorded in the foundation frame of the engine, $n = 1950$ rpm

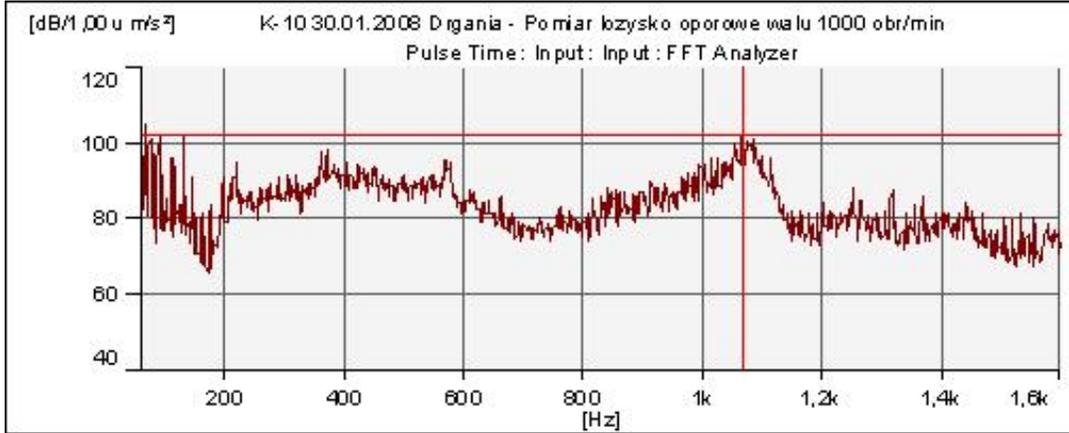
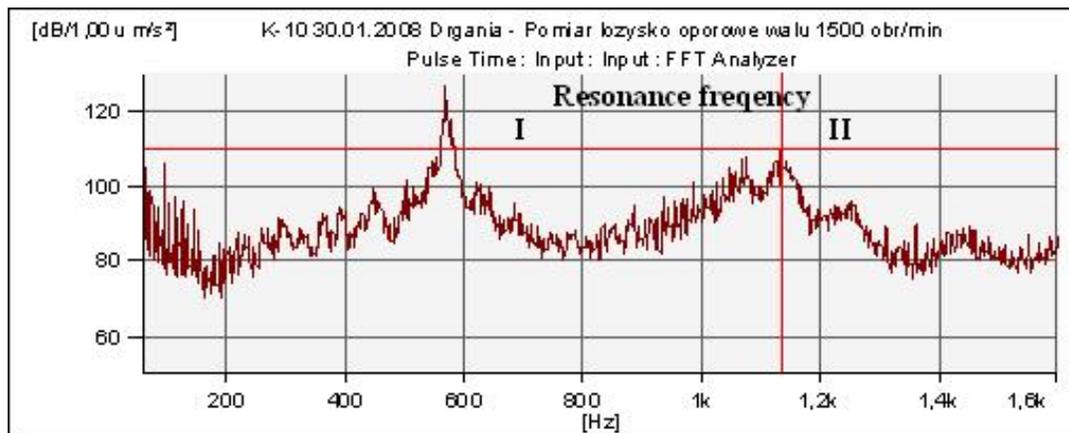
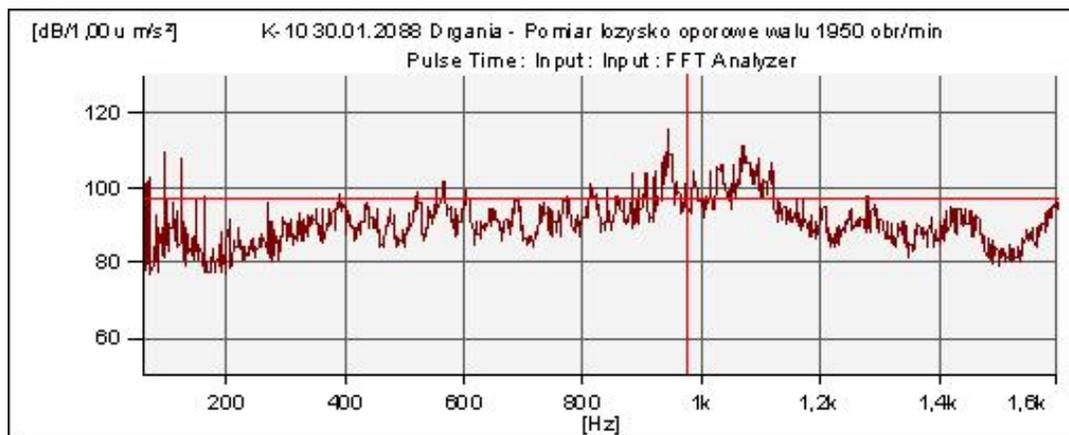
Fig.5 Spectrum of accelerations recorded in the shaft's thrust bearing; $n = 1000$ rpm

Fig.6 Spectrum of accelerations recorded in the shaft's thrust bearing; $n = 1500$ rpm

Fig.7 Spectrum of accelerations recorded in the shaft's thrust bearing; $n = 1950$ rpm

The analysis of presented spectra (figures 5 – 7) of accelerations recorded in the shaft's thrust bearing for engine's rotational speeds $n = 1000, 1500$ and 1950 rpm shows zones of increased vibrations levels.

Spectra of vibrations in the shaft's thrust bearing are presented in figures 5, 6 and 7.

In presented spectra (figures 8 to 10) one may see that in vibrations recorded in the stern room and in the shaft's thrust bearing are visible mentioned earlier zones of increased vibrations for the same rotational speeds of main engines.

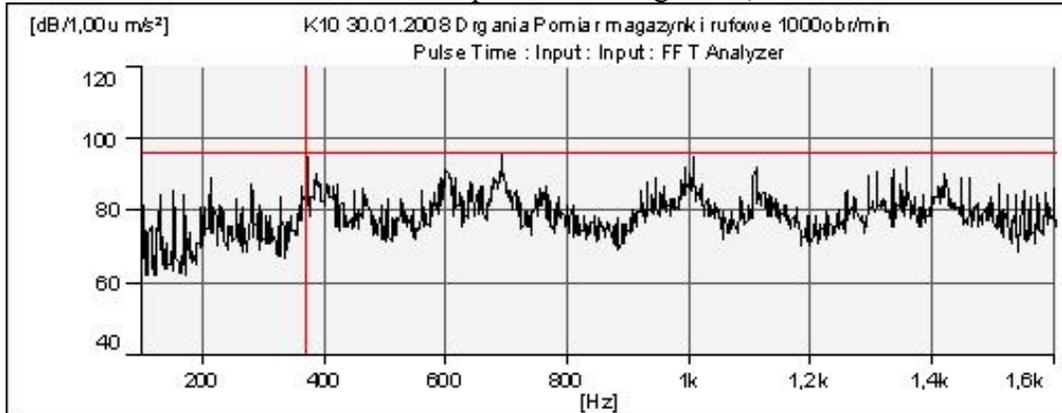
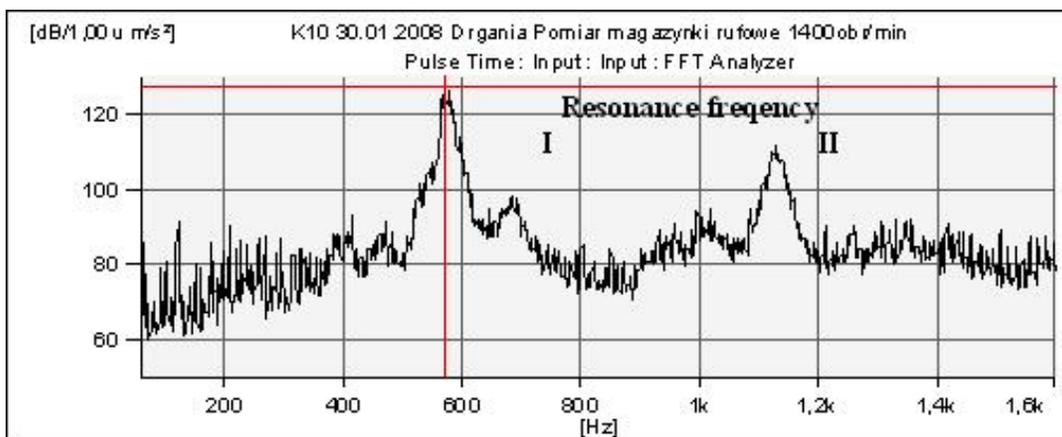
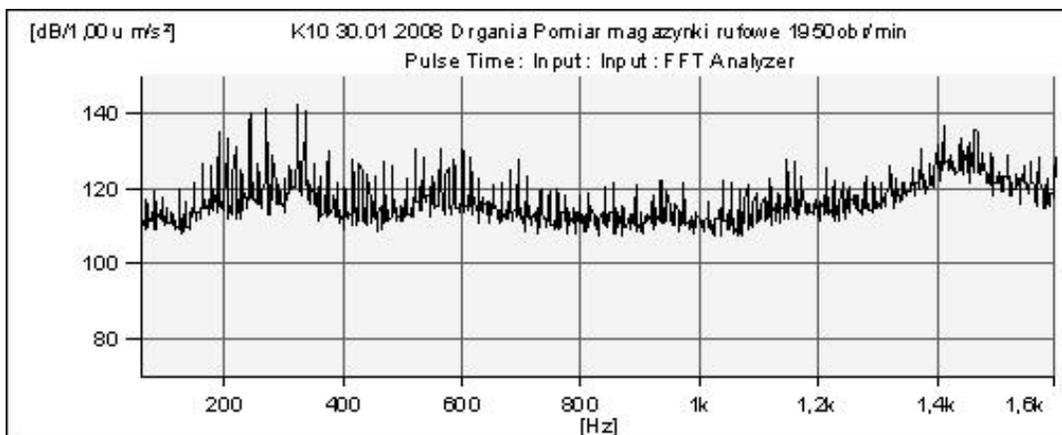
Fig.8 Spectrum of accelerations recorded in the stern room $n = 1000$ rpm

Fig.9 Spectrum of accelerations recorded in the stern room $n = 1400$ rpm

Fig.10 Spectrum of accelerations recorded in the stern room $n = 1950$ rpm

The analysis of presented spectra shows that the probably place of increased pressure in discussed zones is the screw propeller. In order to unequivocally indicate the source was necessary to make a cycle of hydro-acoustic measurements. These measurements were carried out in the proving ground.

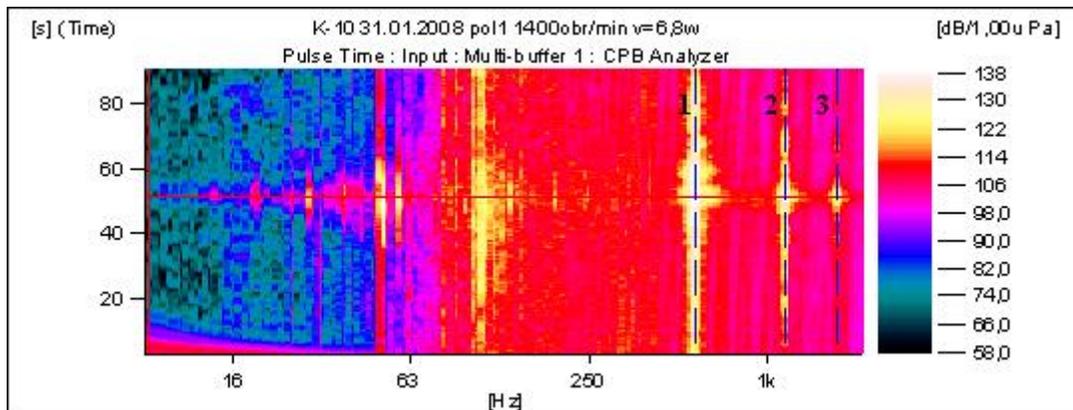
Fig.11 Spectrogram of hydro-acoustic pressure of the ship $n = 1400$ [rpm]

In figures 11 and 12 are visible characteristic components related to operation of the main engine, the power generating unit, with rotational movement of the marine screw propeller and the set of shafts.

where: 1 – basic frequency related to operation of the marine screw propeller; 2 – II harmonic; 3 – III harmonic.

In the spectrogram (figure 11), in the frequency range up to 250 [Hz] are visible characteristic components related to operation of ship mechanisms and devices. Above this frequency is visible the basic frequency related to loud operation of the marine screw propeller with its second and third harmonic. From this spectrogram was separated spectrum recorded in 38.69 [s] of measurement, presented in figure No 12. In this spectrum is marked by blue cursors basic frequency, second and third harmonic. From the description of the figure one may exactly determine frequency of first harmonic – $f = 561.5$ [Hz] and calculate frequency of second and third harmonic.

Measurements of hydro-acoustic pressure of the ship were carried out in the proving ground. Recorded ship's noise are presented in form of a chart with hydro-acoustic pressure level versus time of ship passage through the proving ground and versus frequency. Additionally for each tested speed of ship was carried out the spectrum of hydro-acoustic pressure depending of frequency. This spectrum was selected from the presented spectrogram (figure 11) in place where most loud part of the ship was directly over the acoustic sensor. The exemplary spectrogram and the spectrum of ship cruising through the proving ground is presented in figures 11 and 12.

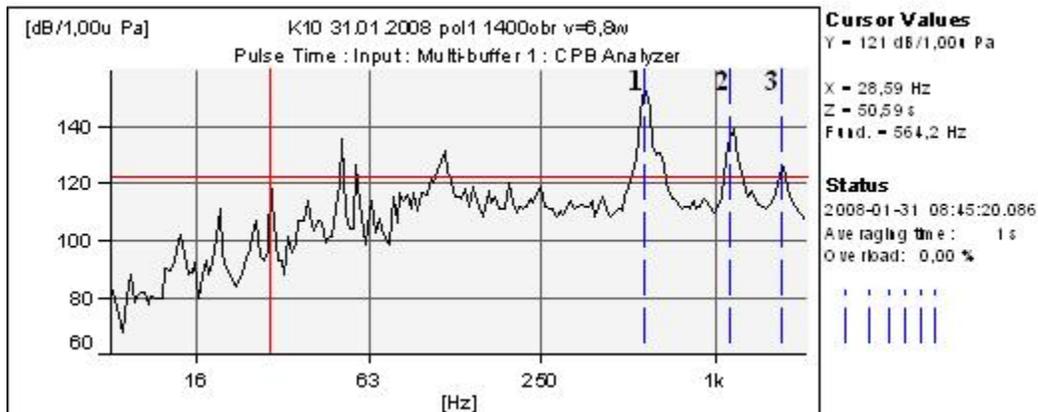
Fig.12 Spectrum of hydro-acoustic pressure of the ship; $n = 1400$ rpm, $v = 6.8$ ktn

In carried out analyses of hydro-acoustic pressure signals recorded in the proving ground also the zones of increased pressure were found; in the same frequency bands. This disadvantageous phenomenon is connected with hydrodynamic processes occurring at marine propeller blades. These processes caused increase of hydro-acoustic pressure by 10 [dB] to 15 [dB], depending of ship speed. The set of shafts and construction elements of the ship transmit these disadvantageous vibrations. Effects of this phenomenon were visible in spectrograms and spectra of vibrations and noise signals recorded in:
